[Docket No. 2002-SW-04-AD; Amendment 39-12736; AD 2002-09-03]

Airworthiness Directives; Eurocopter France Model AS332L2 Helicopters

2002-09-03 Eurocopter France: Amendment 39-12736. Docket No. 2002-SW-04-AD.

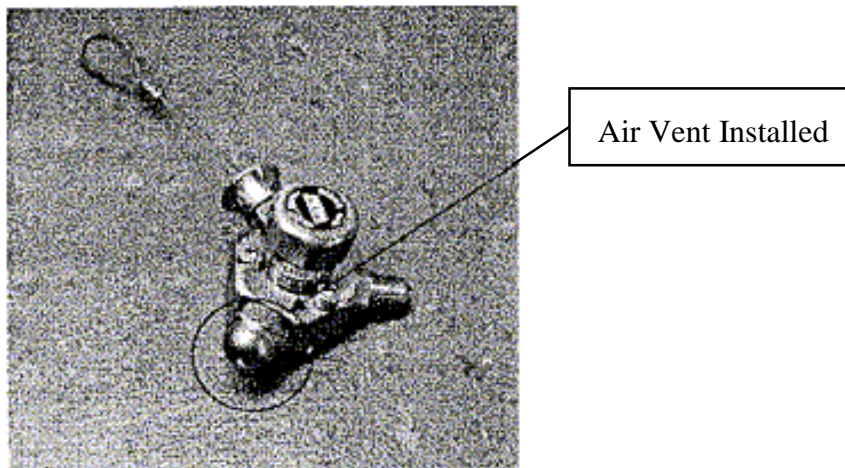
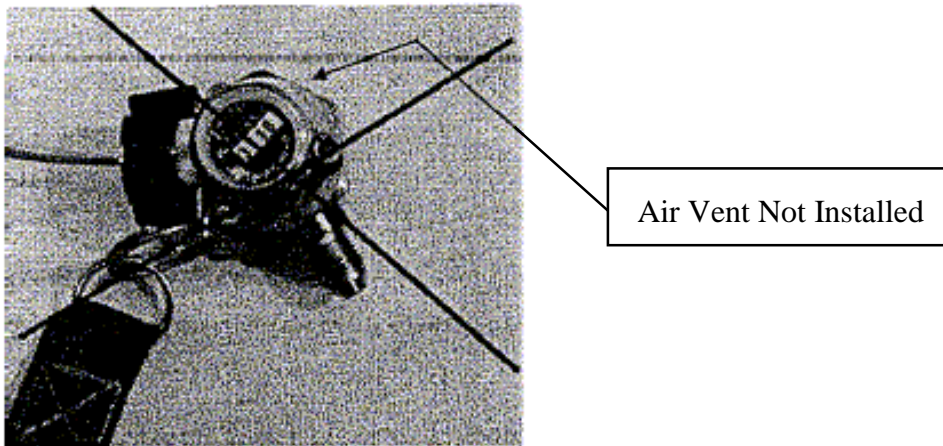
Figure 1

SUPPLEMENTARY INFORMATION: The Direction Generale De L'Aviation Civile (DGAC), the airworthiness authority for France, notified the FAA that an unsafe condition may exist on ECF Model AS332L2 helicopters. The DGAC advises of the discovery of a missing air vent on the head of the inflation cylinder of a life raft. Absence of an air vent on the cylinder head might lead to inadvertent life raft inflation and cause the life raft to be lost and to come into contact with the main or tail rotor.

(a) Verify that the air vent is installed on the head of the inflation cylinder of each lift raft assembly as shown in FIGURE 1:

If the air vent is missing, replace the cylinder head with an airworthy cylinder head before further flight.
